CITY OF GUSTAVUS LIBRARY

ROOF INSPECTION

November 2, 2018

PDC Project No. 18324JN

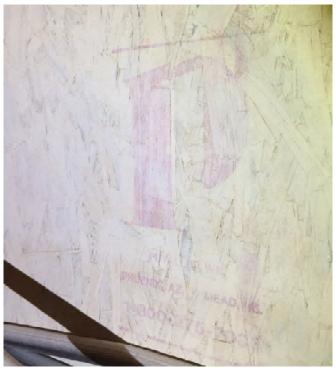
Once on site, Cheryl provided plans and showed photos of the rot they found on the roof. An investigation was done in the attic where there was no sign of rot. A stamp was found on the wall that may be related to the SIP manufacturer, **Figure 1**. We tried to call the number for the SIP manufacturer but the line has been disconnected. Another stamp was found for the structural sheathing manufacturer, **Figure 2**. A walk through of the building was also done, where nothing problematic was noticed.

Figure 1- Possible SIP Manufacturer Stamp "Phoenix, AZ 1-800-275-7000"

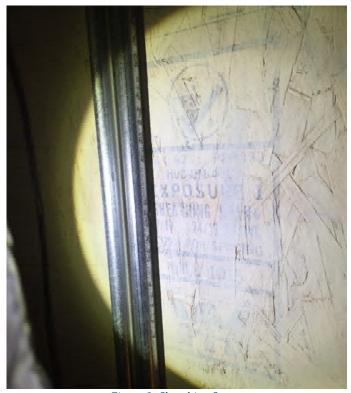
Figure 2- Sheathing Stamp

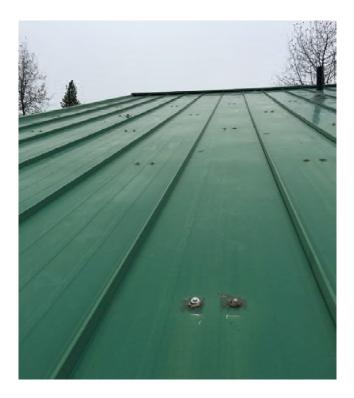
The roof inspection was then conducted. There were lots of screw heads sticking up above the roof. Cheryl said there used to be snow stops on the roof that were ripped off from the snow, leaving the screws, **Figure 3**. Under one of the panels, the screws had created a point of entry for water and contributed to the rotted firring strip, **Figure 4**. The metal ridge vent was removed to expose the tar paper, which was cut to expose the foam. The edges of the SIP top layer of sheathing had rot, **Figures 5-7**. There was also significant rot was about a foot down from the ridge, **Figure 11**. It looks like the rot likely continues beyond the exposed area but the extent is unknown at this time.

Figure 3- Snow Stop Screws

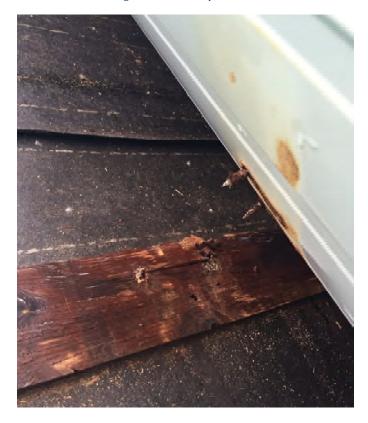
Figure 4- Rotten Wood Under Metal Roofing

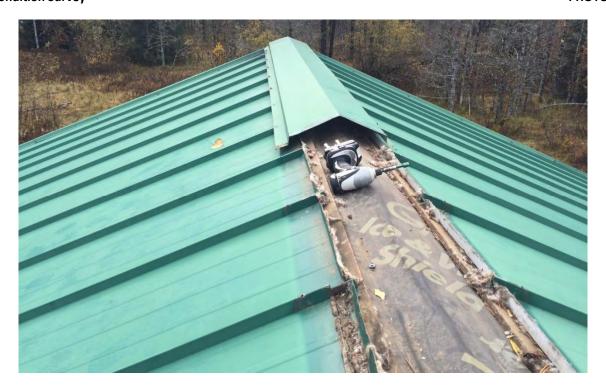
Figure 5- Roof Ridge

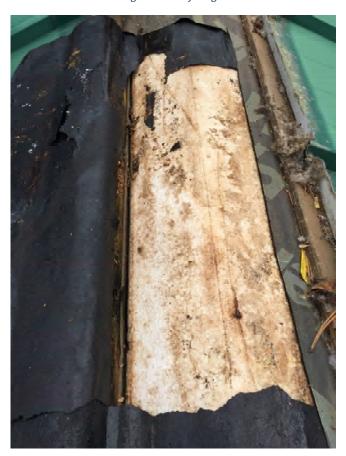
Figure 6- Roof Ridge Foam

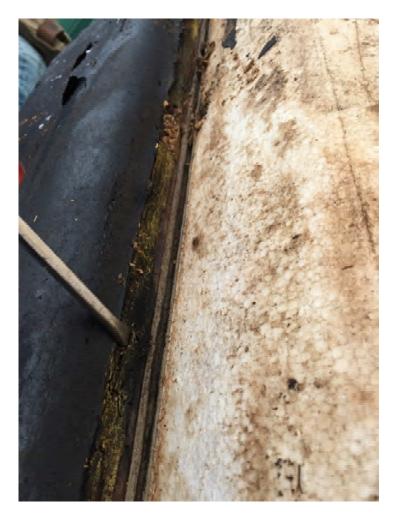
Figure 7- Ridge Foam and Rotten Wood

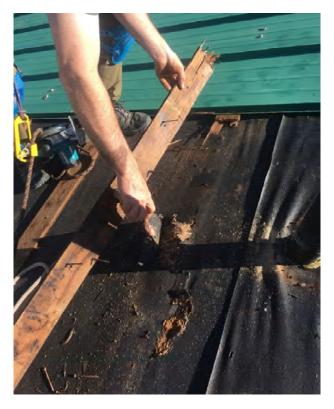
From the provided photos, the worst section of exposed rot observed appears to be approximately 3 feet by 1 foot. It is located below the stack sticking out of the roof, **Figures 8-10**. This location appeared to be at one of the horizontal firring strips. Typically when firring strips are used on the roof, they are installed vertically. This allows any moisture build up to drain down the roof. It also allows the air to ventilate from the eave up to the ridge and out through the ridge cap. Since the firring strips were installed horizontally, they likely held the moisture up on the roof. This indicates there may be rot at each of the firring strips, possible across the entire length of the building, which decreases the overall performance of the SIP. A repair option is discussed below.

Figure 8- Roof Rot Investigation

If there is rot under all of the firring strips, then the top layer of sheathing of the SIP is not performing as it should. To repair, the top plywood and foam would be cut out to allow a member to be placed in the panel, which would provide the span capacity of the assembly. The member would protrude out of the panel and take the place of firring strips and provide the roof with a ventilation gap. There would be a sealant around the SIP to ensure moisture does not get into the panels. By assuming a snow load of 50 psf, three member sizes were calculated to work; 2x12@12"oc, 3x12@16"oc, and 4x12@24"oc. For this option, the new member would act to carry the loads over the span and the SIP would only be used to provide the insulation. Screws should be used to connect the bottom of the SIP with the new rafter. All rafter splices should be strapped and

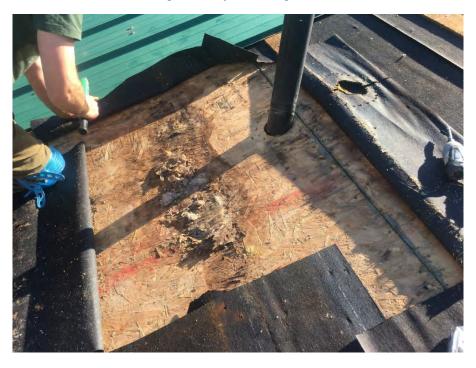
Figure 9- Roof Rot Investigation

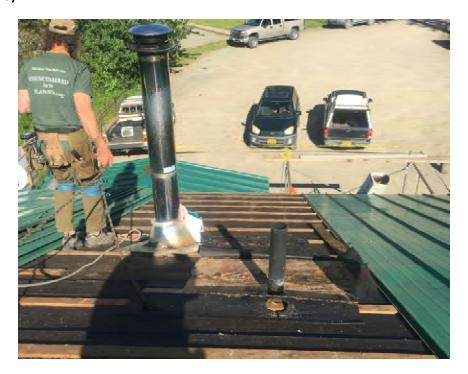
Figure 10- Roof Rot Location

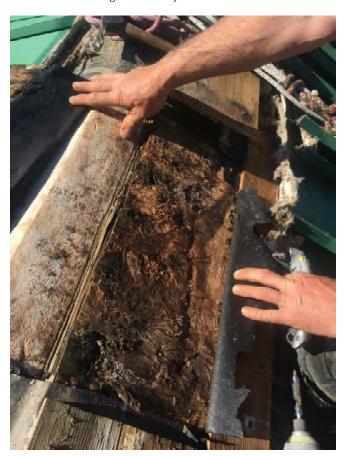
Figure 11- Roof Rot at Ridge
